# CASE STUDY

**Location:** Reversing Falls – Saint John, New Brunswick, Canada

**Application:** Rooftop Observation Platform

**Product:** Aqua Grate® 1215 Pultruded FRP Grating

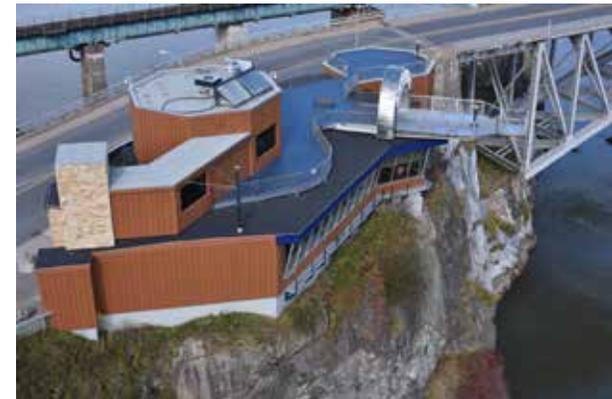
That is why Fibergrate presented the owners with a project that would protect their visitors and save them thousands of dollars in repairs: Aqua Grate Pultruded FRP grating in 3 foot by 10 foot panels on the floor of the observation platform. This material is ADA compliant, and the aqua grit surface of Aqua Grate grating creates a slip resistant surface, increasing pedestrian safety. This grating was engineered to withstand the corrosive conditions associated with recreational foot traffic and wet environments allowing it to endure the snow, salting, and shoveling at the observation platform.

The Aqua Grate Pultruded FRP grating panels exceeded the expectations of the client for its light weight, easy installation, ability to percolate water while protecting the ceiling of the restaurant, and the fact that it was fabricated in a custom blue color opposite to the traditional dark gray. Since the installation in May 2016, the Aqua Grate 1215 gratings have been put to the test by serving millions of visitors.
